# Mass Integrity Home & Pest Inspection

Prepared by: Mass Integrity Home & Pest Inspection, LLC  
55 Glenwood Ave  
Hyde Park, MA 02136

# Mass Integrity Home & Pest Inspection, LLC

18:57 May 21, 2017

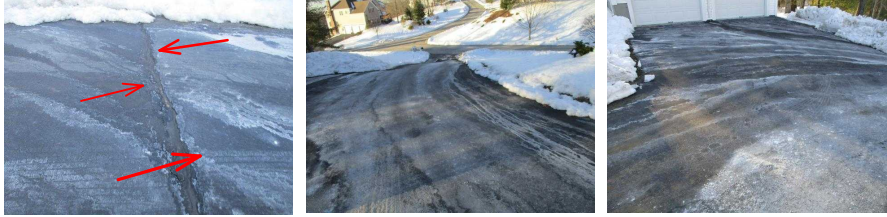
1. ☒ ☐ ☐ ☒ ☐ Driveway: Asphalt - Settled with cracks monitor, Recommend a seal coat be applied in the summer this will help prolong the life of the driveway.

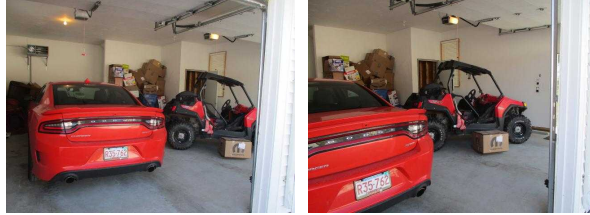
3. ☒ ☐ ☐ ☒ ☐ Door Operation: Mechanized - The electric Auto Reverse Mechanic are not install correct The Auto Reverse Electric help prevent Accidental Injuries or Damage when an Object is in its path of the floor .Relocate Eye at a point of 4 to 6 inches from Garage Floor

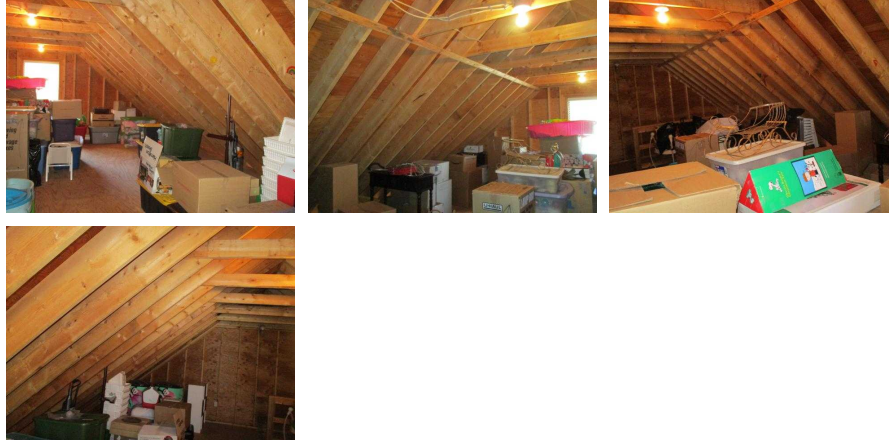
7. ☒ ☐ ☐ ☐ ☐ Roof Structure: 2x12 Rafter - Recommend adding hand railings on steps leading to attic

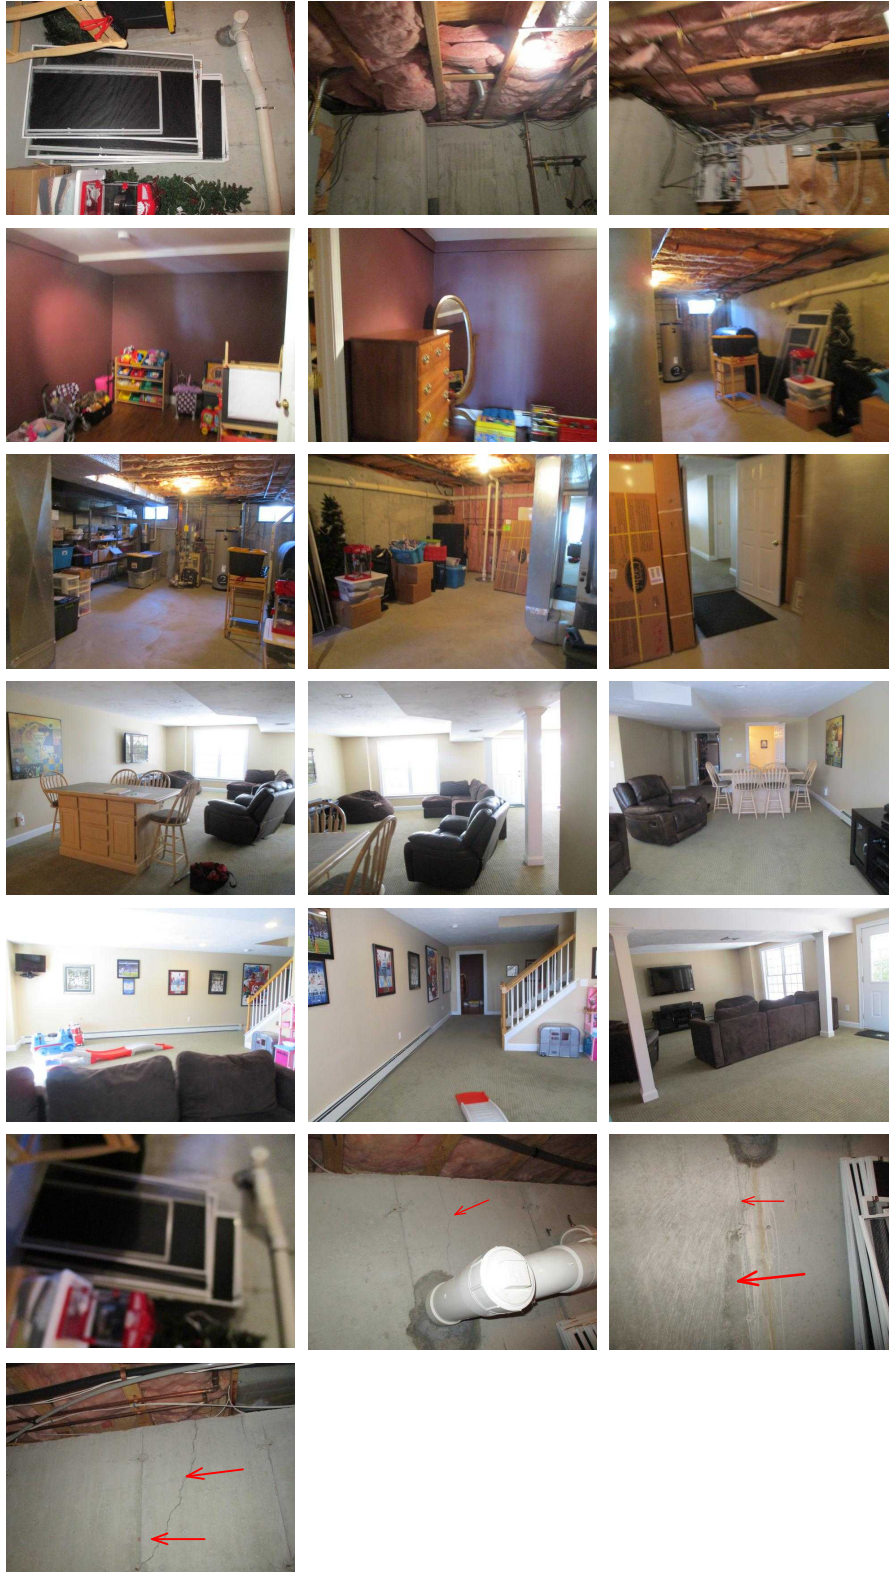
| 2. | <input checked="" type="checkbox"/> | <input type="checkbox"/> | <input checked="" type="checkbox"/> | <input type="checkbox"/> | <input type="checkbox"/> | Foundation: Poured, Finish walls - Be advise that finished or semi finished floor, walls and ceiling at the basement level prevented visual analysis of the structural elements and mechanical system of the home. Please understand that the home inspector did an earnest job where accessible to alert you regarding observed or suspected problems,true conditions remain undetermined. be advised that the removal of floors, walls or ceiling covering may revealed hidden problems that were not disclosed in this report. Settlement Cracks noted . |

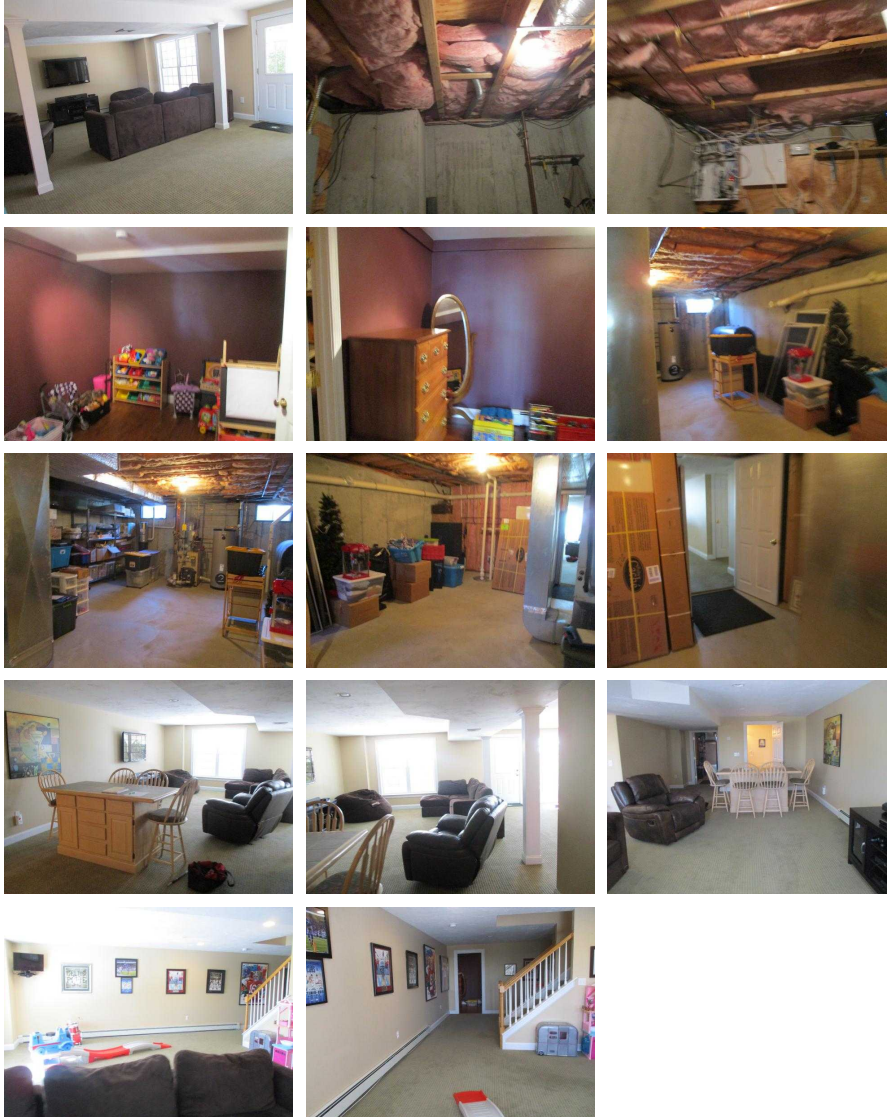
1. ☐ ☐ ☒ ☐ ☐ Unable to Inspect: 90% - Be advised that finished or semi finished floor,walls and ceilings at the basement level prevented visual analysis of the structural elements and mechanical system of the home. Please understand that the home inspector did an earnest job where accessible to alert you regarding observed or suspected problem,true conditions remain undetermined. Be advise that the removal of floor, walls or ceiling covering mar reveal hidden problems that were not disclosed in this report.

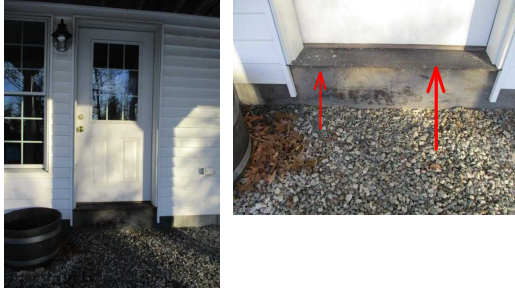
4. ☒ ☐ ☐ ☐ ☐ Floor: Concrete and carpeting  
 5. ☐ ☒ ☐ ☐ ☐ Floor Drain: Non Present.  
 6. ☒ ☐ ☐ ☒ ☐ Doors: Metal and Glass - Riser is higher that required height

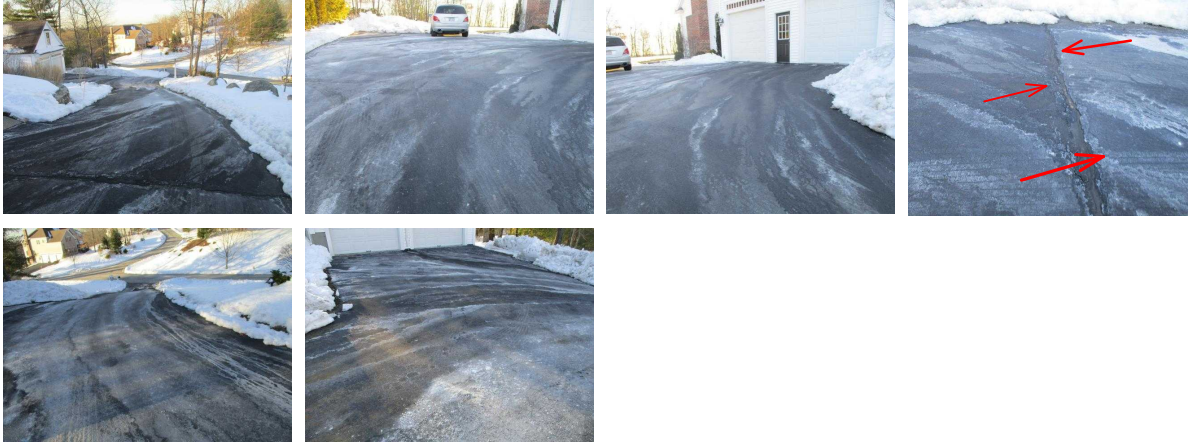
1. Driveway: Asphalt - Settled with cracks monitor, Recommend a seal coat be applied in the summer this will help prolong the life of the driveway.

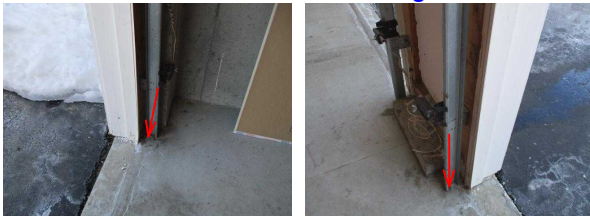
2. Detached Garage Door Operation: Mechanized - The electric Auto Reverse Mechanic are not install correct The Auto Reverse Electric help prevent Accidental Injuries or Damage when an Object is in its path of the floor .Relocate Eye at a point of 4 to 6 inches from Garage Floor

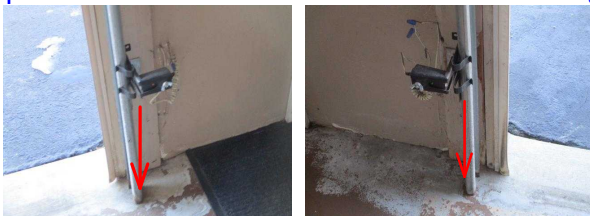
3. Tuck under Garage Door Operation: Mechanized - Th, The electric Auto Reverse Mechanic are not install correct The Auto Reverse Electric help prevent Accidental Injuries or Damage when an Object is in its path of the floor .Relocate Eye at a point of 4 to 6 inches from Garage Floor
