# Mass Integrity Home & Pest Inspection

Prepared by: Mass Integrity Home & Pest Inspection, LLC  
55 Glenwood Ave  
Hyde Park, MA 02136

# Mass Integrity Home & Pest Inspection, LLC

18:57 May 21, 2017

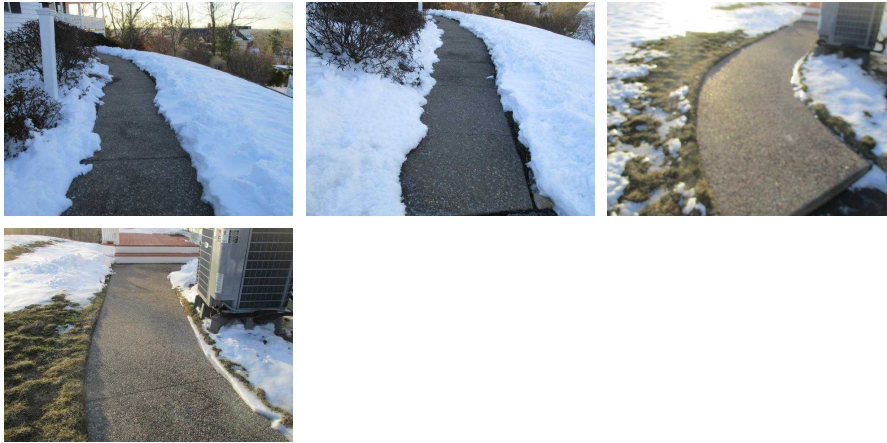
2. ☒ ☐ ☐ ☐ ☐ Walks: Concrete

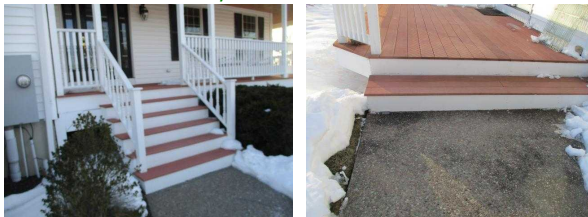
3. ☒ ☐ ☐ ☐ ☐ Steps/Stoops: Front and Rear Steps. Both entry steps and stoops are P.T Lumber built, with trek treads front have wood railings

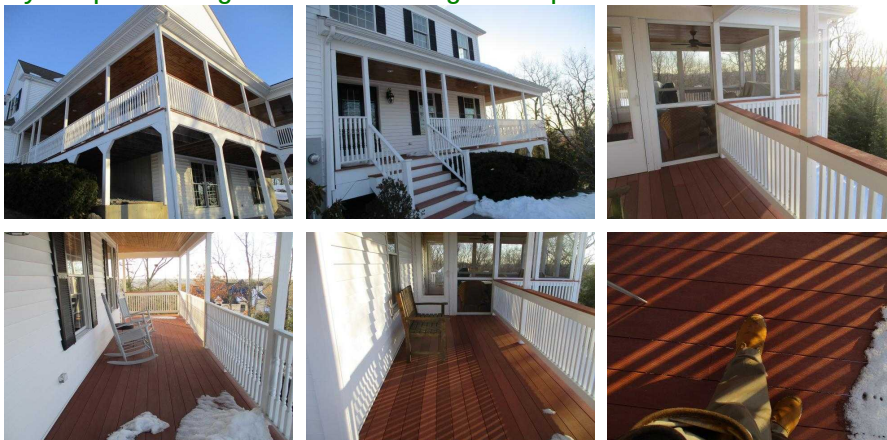
4. ☒ ☐ ☐ ☐ ☐ Porch: Front and side of building - Front porch was built using P.T wood frame with trek decking with wood Hand railings and balusters. Porch were built using good building technique 2 by 12 on 16 with 6 by 6 post lag and flashing are present

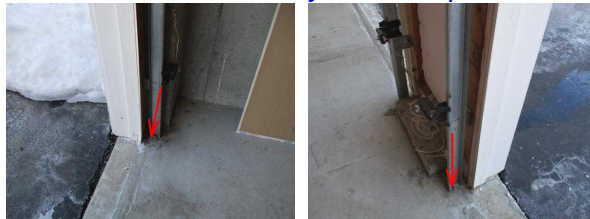
3. ☒ ☐ ☐ ☒ ☐ Door Operation: Mechanized - The electric Auto Reverse Mechanic are not install correct The Auto Reverse Electric help prevent Accidental Injuries or Damage when an Object is in its path of the floor .Relocate Eye at a point of 4 to 6 inches from Garage Floor

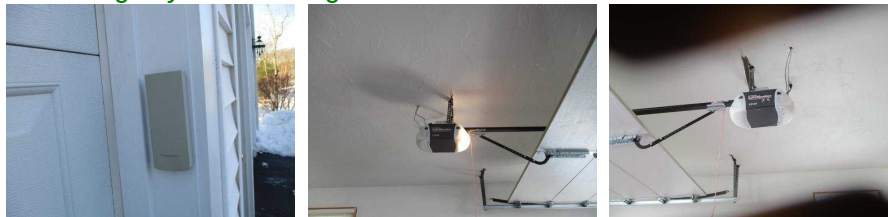
4. ☒ ☐ ☐ ☐ ☐ Door Opener: Lift Master - There is an entry exterior key pad on the outside, combination will be given to new buyers at the day of closing by their agent.

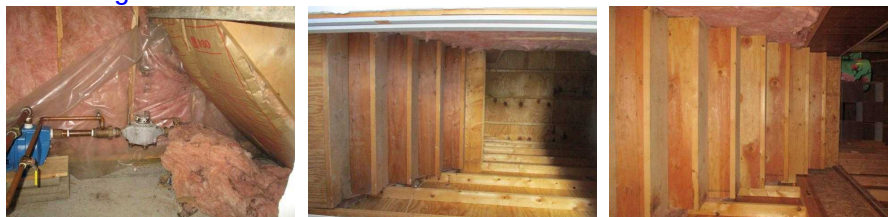
7. ☒ ☐ ☐ ☐ ☐ Roof Structure: 2x12 Rafter - Recommend adding hand railings on steps leading to attic

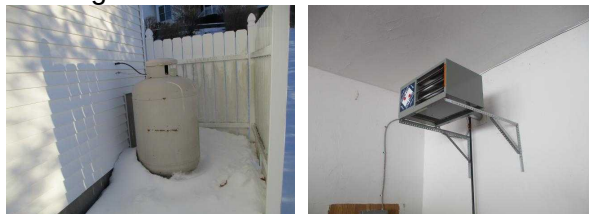
15. ☐ ☒ ☐ ☐ ☐ Heating: Moden Blower.

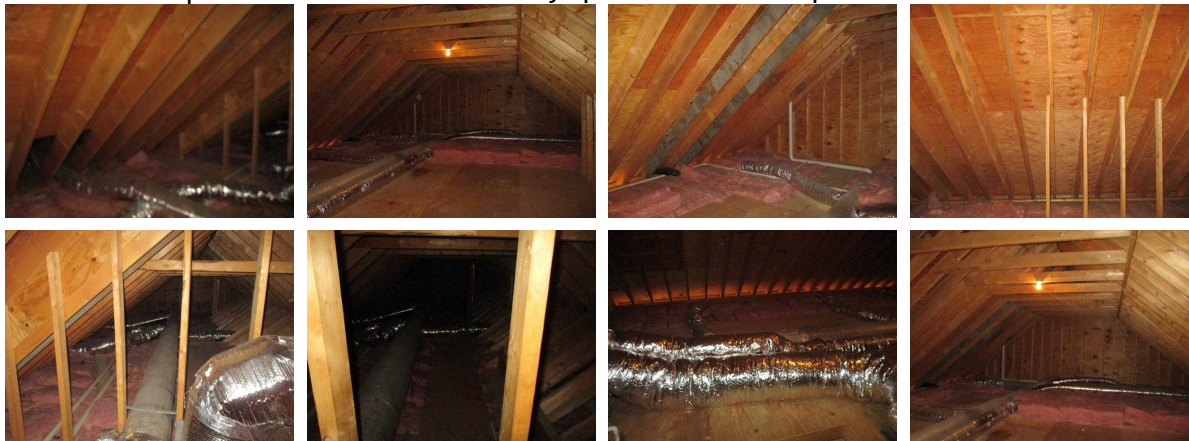
1. Method of Inspection: In the attic by pull down steps.

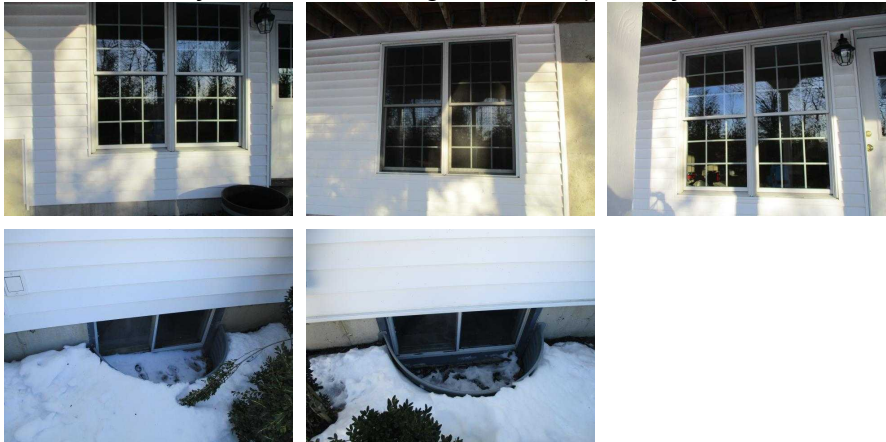
7. ☒ ☐ ☐ ☐ ☐ Windows: Vinyl Double Hung Thermo., Vinyl Slider.

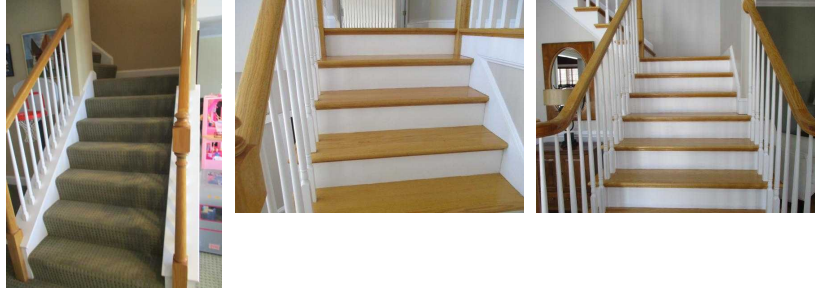
8. ☒ ☐ ☐ ☐ ☐ Electrical: 110 VAC outlets and lighting circuits  
 9. ☐ ☐ ☒ ☐ ☐ Smoke Detector: Smoke detectors are not inspected at time of inspection. It is the responsibility of the seller to obtain a smoke certificate from the local fire department. **Smoke Detectors and Carbon Monoxide Detectors were not assessed. The assessment is to be performed by Local/State Jurisdiction prior to Occupancy .**  
 10. ☒ ☐ ☐ ☐ ☐ HVAC Source: Convection baseboard, A/C Vent  
 11. ☒ ☐ ☐ ☐ ☐ Vapor Barrier: Paper  
 12. ☒ ☐ ☐ ☐ ☐ Insulation: Batting  
 13. ☒ ☐ ☐ ☐ ☐ Ventilation: Windows  
 14. ☐ ☒ ☐ ☐ ☐ Sump Pump: None Present.  
 15. ☐ ☒ ☐ ☐ ☐ Moisture Location: None Present.  
 16. ☒ ☐ ☐ ☐ ☐ Basement Stairs/Railings: Wood steps cover with carpet., wood steps wood railings.

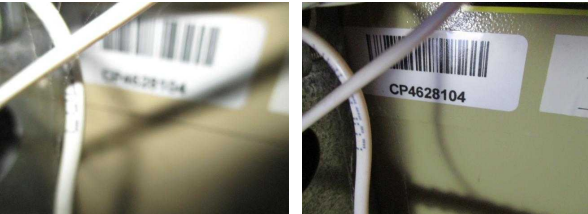
3.

4. Type: Boiler system Capacity: 100,000 BTUHR

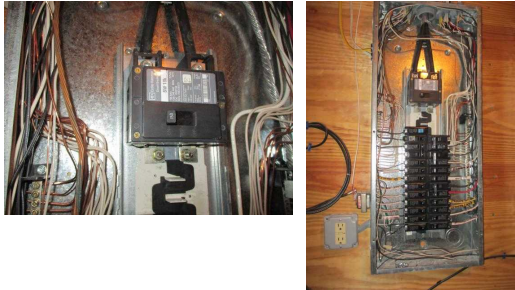
11. ☒ ☐ ☐ ☐ ☐ Main Breaker Size: 150 - The Main Service is a Breaker, this breaker is properly sized to the service conductor unless otherwise stated.

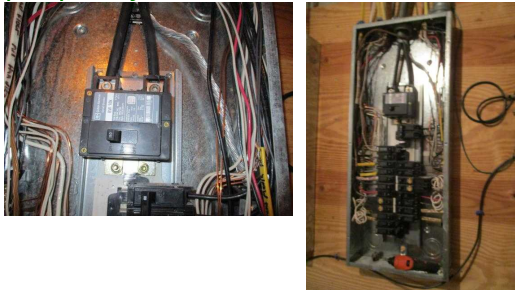
19. ☒ ☐ ☐ ☐ ☐ Main Breaker Size: 150 - The Main Service is a Breaker, this breaker is properly sized to the service conductor unless otherwise stated.

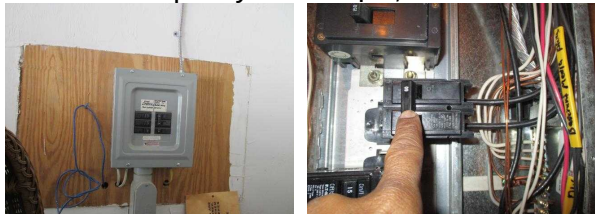
26. Maximum Capacity: 60 Amps, Main shut of is located in the main service paneling.

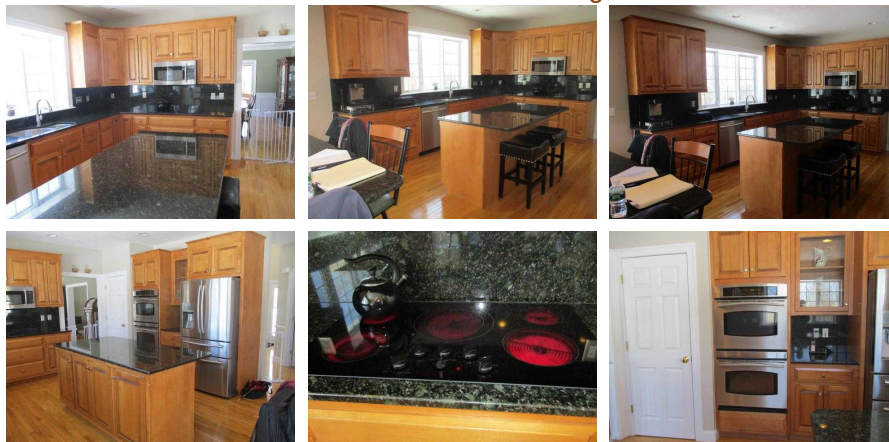
1. ☒ ☐ ☐ ☐ ☐ Cooking Appliances: Electric, Cook top - Only the burners were tested oven was not tested due to cooking utensils stored inside.
